NASA Contractor Report 166015

Advanced Manufacturing Development of a Composite Empennage Component for L-1011 Aircraft

**PHASE V — FINAL REPORT
FULL SCALE GROUND TEST**

**LOCKHEED-CALIFORNIA COMPANY
BURBANK, CALIFORNIA**

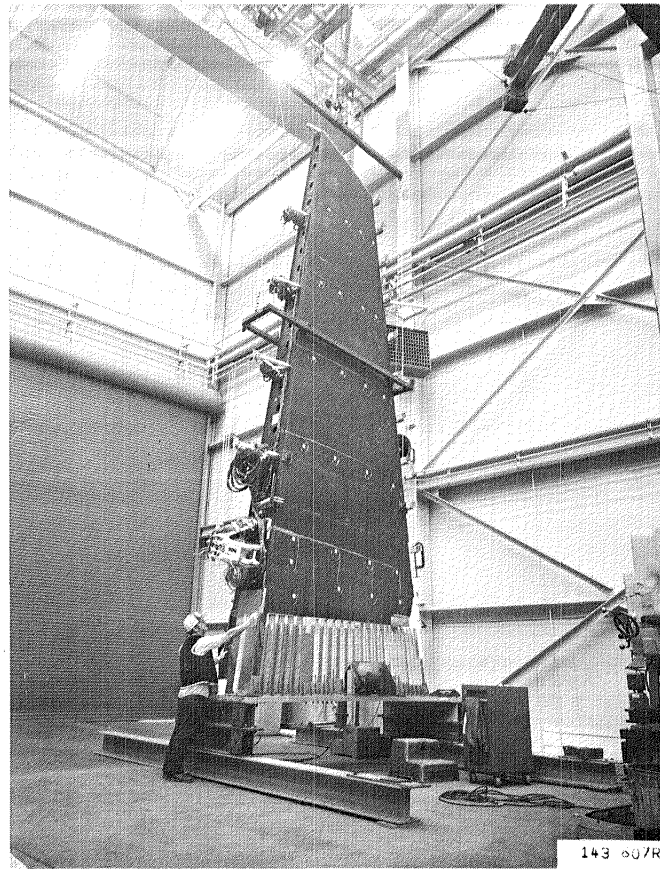
Figure 16. - Fin and transition structure mated.

The fin and transition structure were than mated in a vertical position as shown in Figure 16. Some mismatches were found at the spar caps due to warpage of the splice angles during machining. The mismatches were shimmed and all joint holes pilot drilled from the inside out. The fin and transition structure were then separated and cleaned to remove dust from drilling. Fay-ing surface sealant was applied and the two parts remated. The holes were

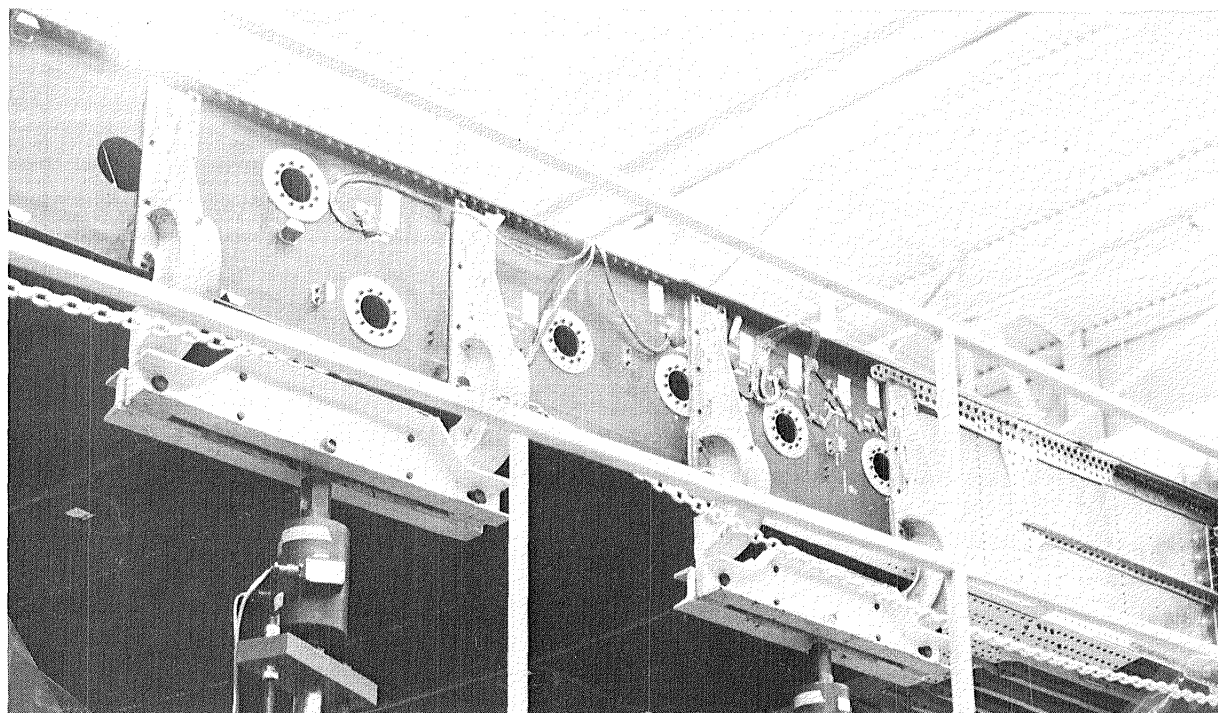
Figure 29. - Front spar web access hole reinforcement.

3.1.1 Test History.-During one of the pretest strain surveys, close examination revealed a buckle developing in the edge of one of the access holes in the lower portion of the front spar at about 30 percent DUL, although no buckling was detected by strain gages away from the hole up to limit load. Based on prior subcomponent tests, no buckling had been anticipated at a hole edge below limit load and no buckling away from the edge below ultimate load. As the spar had not been designed for diagonal tension loads, it was decided to stabilize the lower six access holes by clamping the edges between two aluminum rings to prevent the web from buckling. The installed rings are shown in Figure 29. Ground testing was initiated on May 14, 1981. The fin box was first loaded to Design Limit Load (DLL), or 2/3 DUL for Condition No. 59. A review of selected quick-look data channels showed that the fin box was performing as predicted. While the data were being reviewed the loading was reduced to 10 percent and held. This was standard procedure throughout the test.

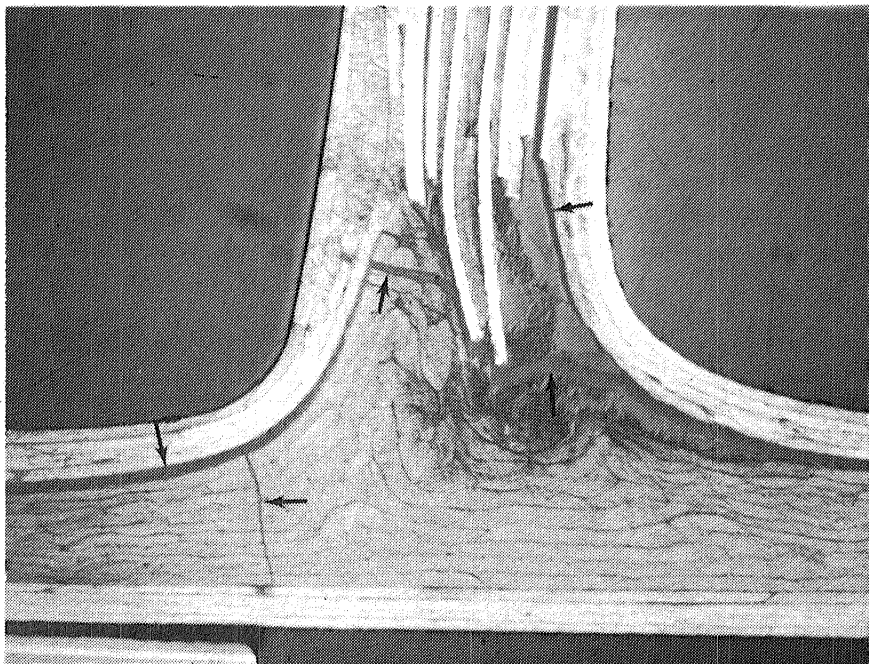
Figure 38. - Photomicrograph of section from GTA No. 1 front spar cap, right side at VSS 277.4.

A review of the design details uncovered a deficiency in the spar design. The front spar cap and web-to-cap configuration in the area of the primary failure is shown in Figure 37. This portion of the cap consists of four plies of $+45^\circ$ or -45° orientation, then ten plies of 0° orientation, and four more $+45^\circ$ or -45° plies. The four plies from each side of the spar web are continued around to become part of the spar cap. The remaining twelve plies terminate at the cap. A photomicrograph (Figure 38) of a section of the right hand spar cap, with a similar configuration to the left hand cap in the primary failure zone, shows that failure has initiated in this location. The four plies of web material are separated from 0° cap material through the radius and into the flange. A crack extends across the web. A microcrack is also visible in the spar cap. By contrast Figure 39 shows a photomicrograph of a comparable section taken from an untested spar cap. No cracks are visible in this section.

A redesign of the spar includes taking all the web plies around into the cap and the cap would be designed for a minimum out of plane loading.

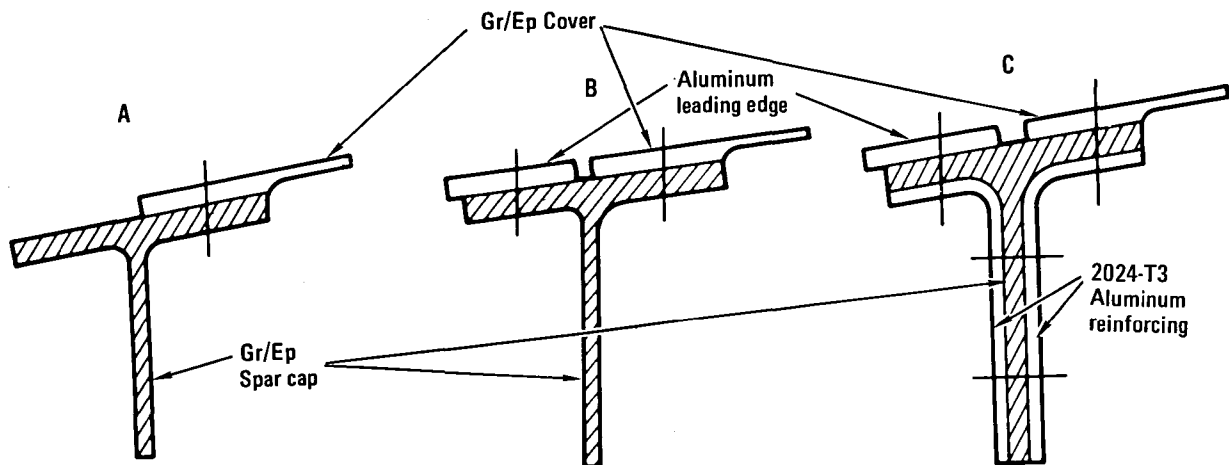
Figure 42. - Interlamina tension specimen configurations.

The results of the interlamina tension tests on the spar caps are shown in Table 1. The specimen configurations and set-up are shown in Figures 42 and 43. A reinforced spar cap segment was also tested, this is configuration C. The reinforcement consisted of adding back-to-back 2024-T3 aluminum angles.

Specimen	Configuration*	Prior Load	Test Load lb/Fastener		Remarks
			Initial Failure	Final Failure	
GTA Spar	A	98% DUL	37.5	43.7	Prior Damage Evident
	A	98% DUL	23.7	34.5	
	A	98% DUL	-31.2	-31.2	
Virgin Spar	A	None	88.7	88.7	— — L.E.*** Attached Reinforced
	A	GTA Pre-loading	52.8	56.4	
	B	None	75.7	75.7	
	C	None	171.6	171.6**

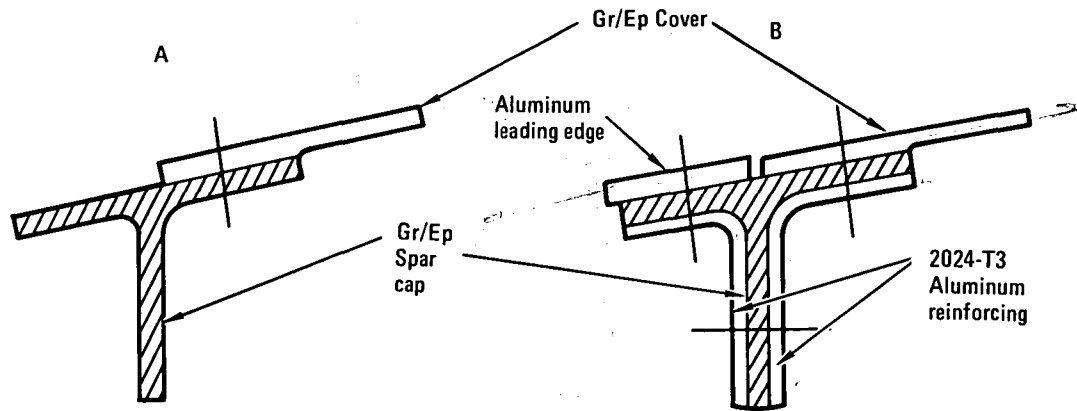
Figure 44. - Transverse tension specimen configurations.

Transverse tension tests were performed to evaluate the offset bending effect of loading due to Poissons effects in the cover and other transverse loads carried into the spar cap. These results are shown in Table 2 and the specimen configurations and set-up are shown in Figures 44 and 45.

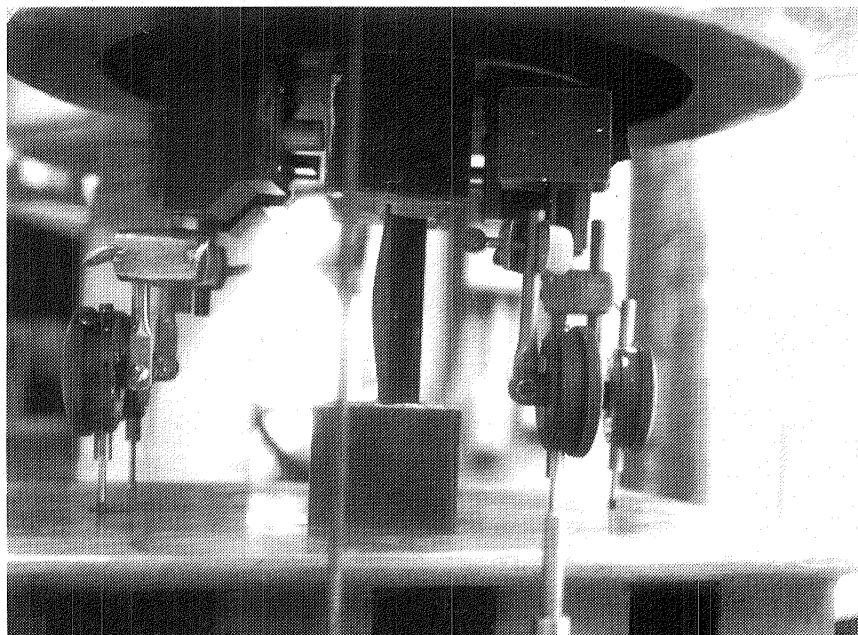
Figure 46. - Rib cap crippling test.

A section of rib cap was cut from the left hand cap of the VSS 171.42 rib toward the rear spar. Visual and C-scan inspection showed no damage in this section. Crippling tests were performed on two sections from this rib cap. The set-up is shown in Figure 46. Failure occurred at 7,110 pounds and 7,980 pounds. The theoretical crippling load was 6,900 pounds.

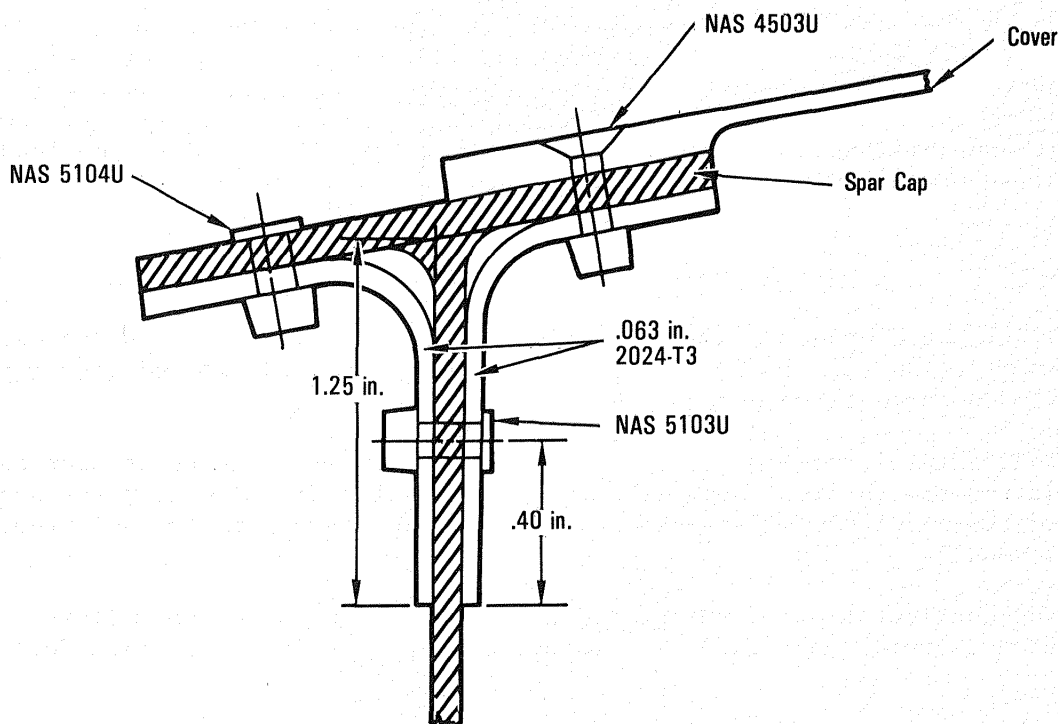
Figure 47. - Spar cap reinforcement.

The configuration of the spar cap in the region where the failure initiated is shown in Figure 37. In order to provide more strength for

out-of-plane loads, the existing spar caps were reinforced with formed aluminum angles from root to tip. Figure 47 shows the configuration of the angles which are 0.063 in. thick 2024-T3 material. The angles were installed in short lengths (approximately 3 inch) to minimize their picking up axial load.

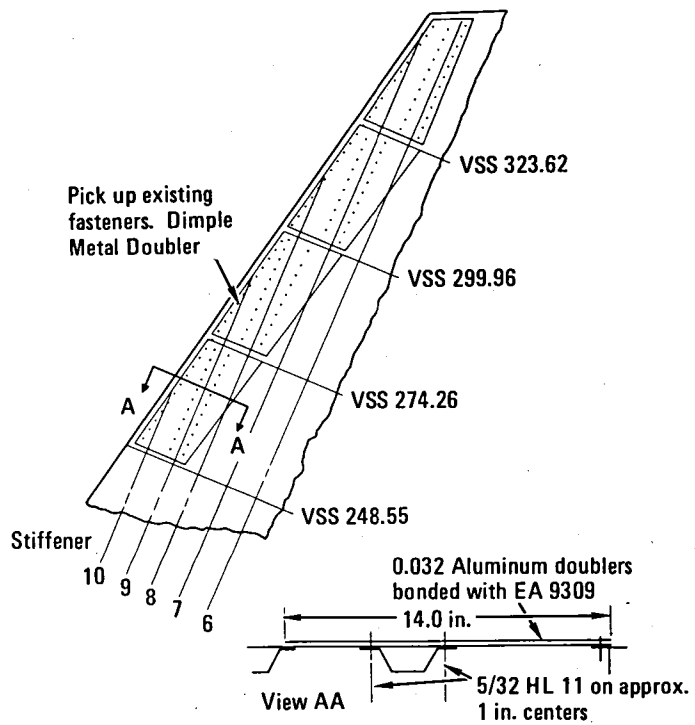
Figure 49. - Cover doublers.

The trapezoidal skin panels adjacent to the front spar in the 10-ply skin area above VSS 248 buckle in shear below limit load. A typical panel is shown in Figure 41. During the failure sequence on GTA No. 1 the stiffeners adjacent to the front spar debonded primarily along the forward flanges in the 10-ply area. The skin was too thin to countersink for fasteners to preclude the debonding of the skin and stiffener in the run-out bays. For the test article 0.032 aluminum doublers were bonded and mechanically attached to both covers locally as shown in Figure 49. These doublers were dimpled at the front spar cap to fit the existing countersinks. The doublers also were countersunk, for the 5/32 inches diameter HL11 fasteners installed along the stiffener flanges.

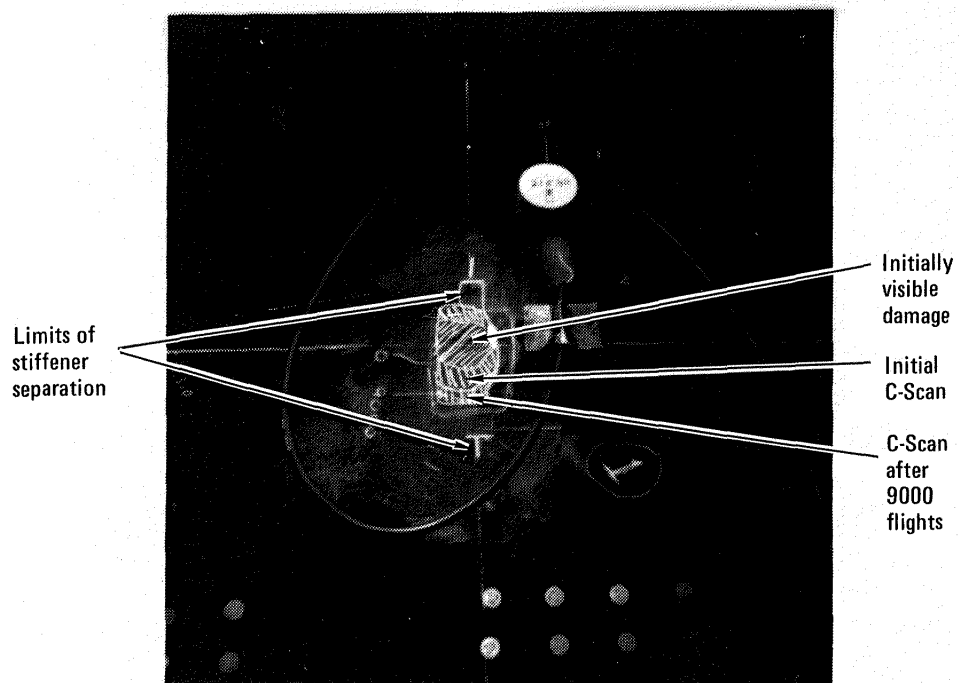
Figure 54. - Location No. 1 damage growth.

Impact No. 1 was in the 16-ply skin area near the aft region of the cover root end. One impact at 13.33 ft.-lb was sufficient to cause visible surface damage.

Damage tolerance testing commenced. At the completion of each one-quarter lifetime (9,000 flights) of fatigue loading the impacted areas were inspected ultrasonically and damage growth, if any, marked on the part. Figures 54 through 58 show the damage and growth at each of the five locations. Most growth occurred during the first half lifetime of fatigue cycling and could only be determined ultrasonically.

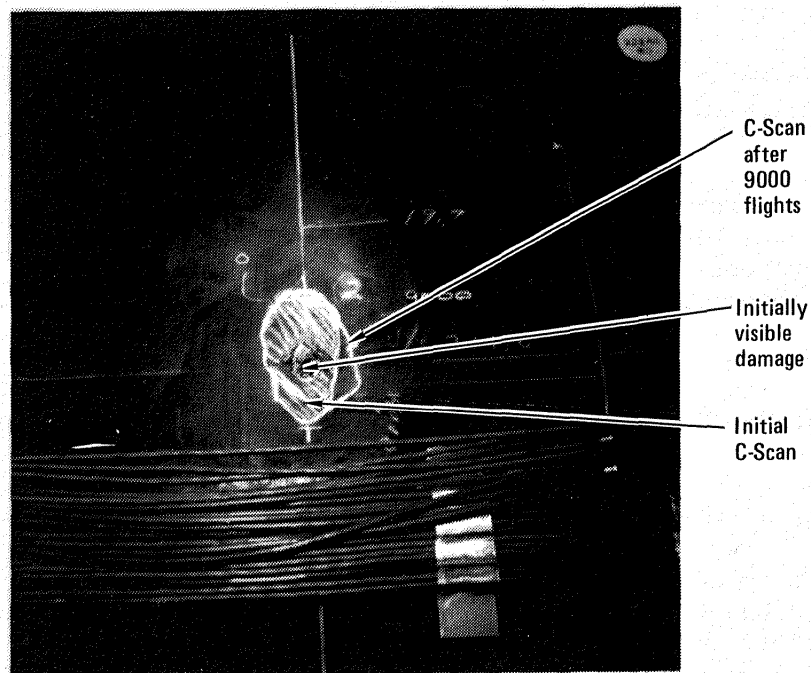
Figure 55. - Location No. 2 damage growth.

Impact No. 2 was in the 14-ply skin area. Four impacts were required to obtain visible damage. The first impact was a 13.33 ft.-lb. Some damage was evident ultrasonically. A second impact at 8.64 ft.-lb. showed no evidence of change ultrasonically. A third impact, now back at 13.33 ft.-lb. gave no visible damage but increased the damage area determined ultrasonically. A fourth impact was made, but at an energy level of 18.95 ft.-lb. Visible penetration through the thickness occurred.

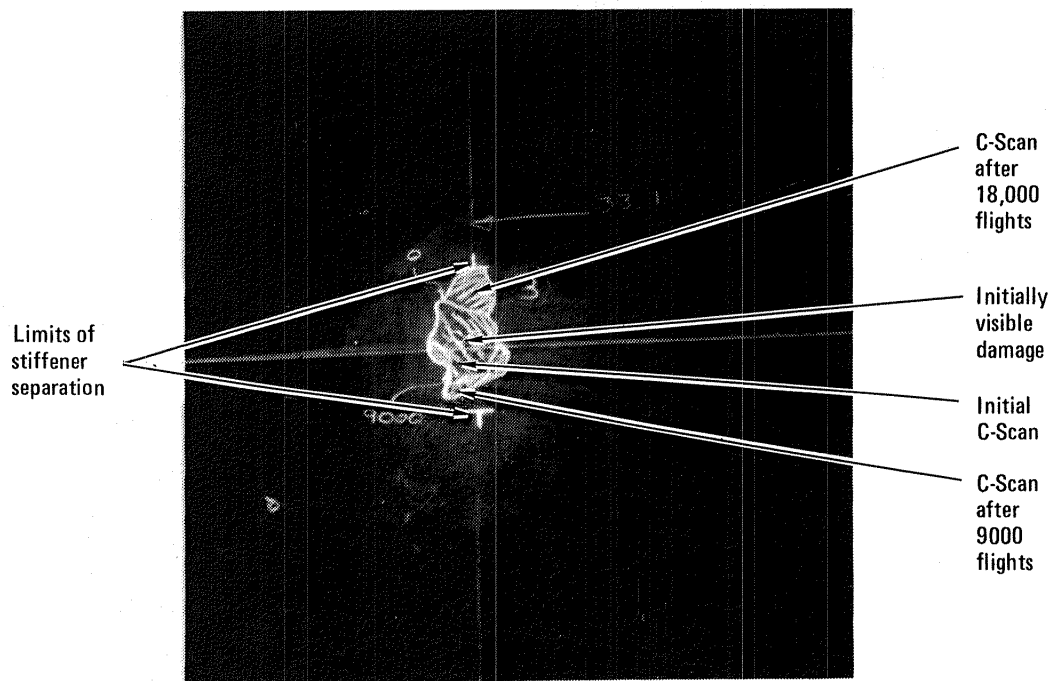
Figure 56. - Location No. 3 damage growth.

Impact No. 3 was in the 10-ply skin area. Because the impact in the 14-ply area required more energy than the calibration had indicated, this area was impacted at 13.33 ft.-lb. also. One impact caused visible surface damage.

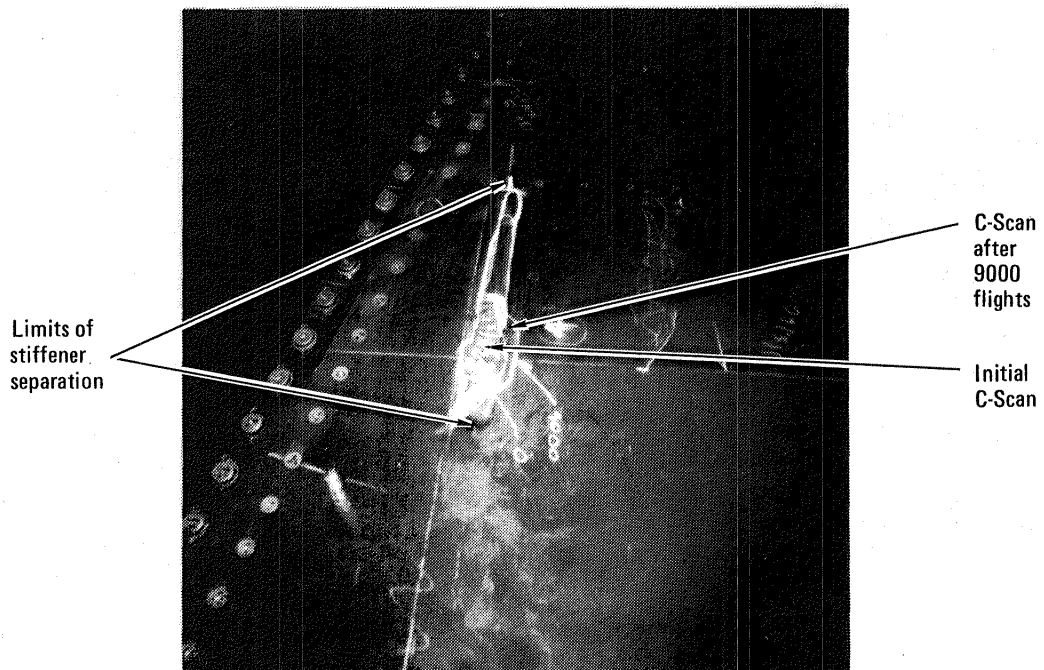
Figure 57. - Location No. 4 damage growth.

Impact No. 4 was in the 16-ply skin area adjacent to the front spar. Because this area was very rigid it was anticipated that lower impact levels would cause damage. However after six impacts at 8.64 ft.-lb. no visible damage occurred internally or externally, and the ultrasonically determined damage area remained essentially unchanged after the first impact. Two more impacts at the higher energy level of 13.33 ft.-lb. again made little difference. There was some evidence of hat flange skin separation extending to the rib about three inches away. It was decided to do no more impacting in this area and to show that nonvisible damage would not grow to catastrophic proportions during a lifetime of loading.

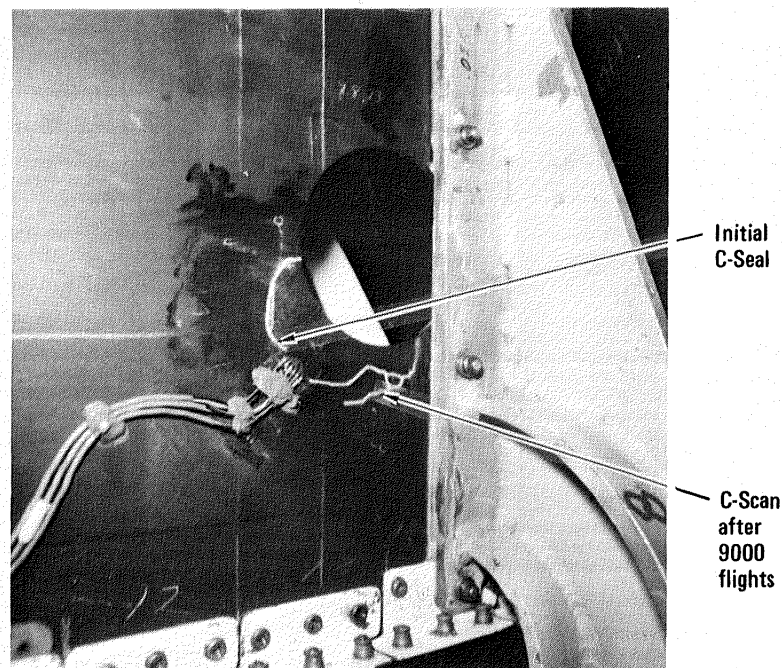
Figure 58. - Location No. 5 damage growth.

Impact No. 5 was on the front spar web at the lowermost unreinforced access hole. The first impact at 7.99 ft.-lb. gave no visible damage. A second impact of 12.52 ft.-lb. gave visible delamination of the surface and in the edge of the access hole.

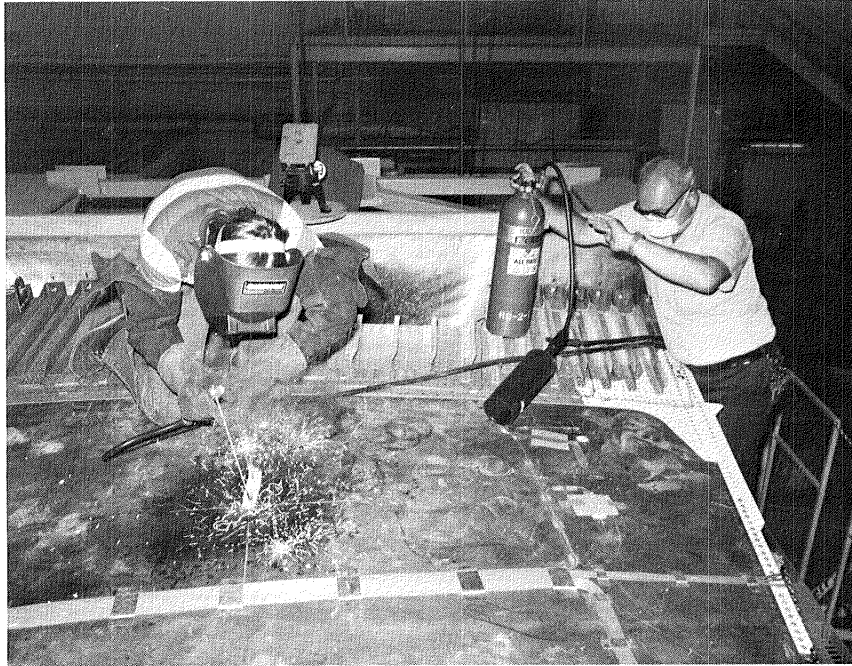
Figure 59 shows the hole being burned through the cover and Figure 60 shows the overall charring operation. The resulting overall damage is shown in Figure 61.

Figure 59. - Burning hole with electric arc welding rod.

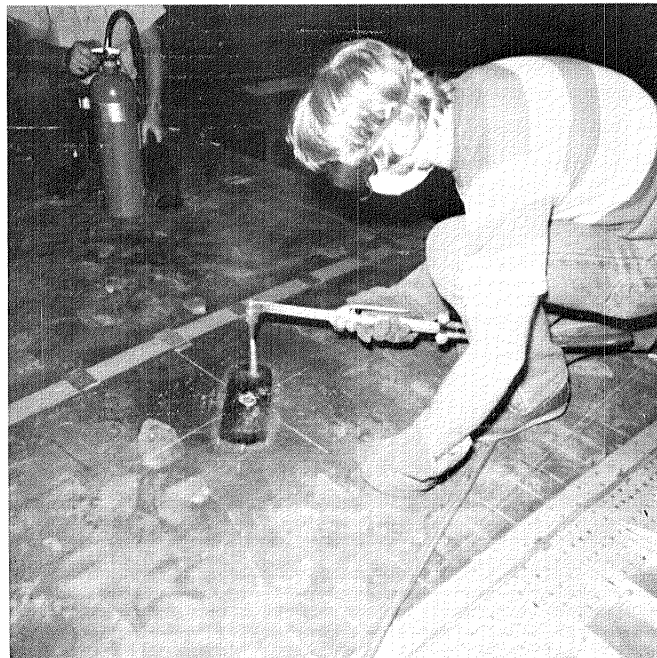
Figure 60. - Charring with oxygen/acetylene flame torch.

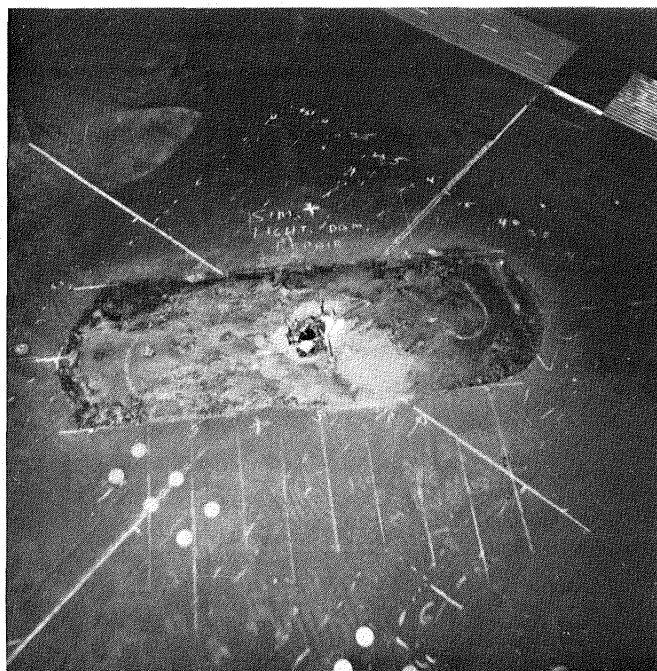
The fin box was then loaded to 1.06 Design Limit Load in both directions, so the damaged cover was loaded once in tension and once in compression. A post test ultrasonic inspection showed no growth in any of the damage.

Figure 61. - Overall simulated lightning damage.

The discrete source damage was then cleaned up for repair. The burned through hole was surrounded by badly charred resin and required opening up to a 2 in. by 2 in. hole. The hole was filled with a room temperature setting compound and a precured block of graphite/epoxy of the same thickness. The surface of the damaged area was cleaned with Scotchbrite and then wiped with

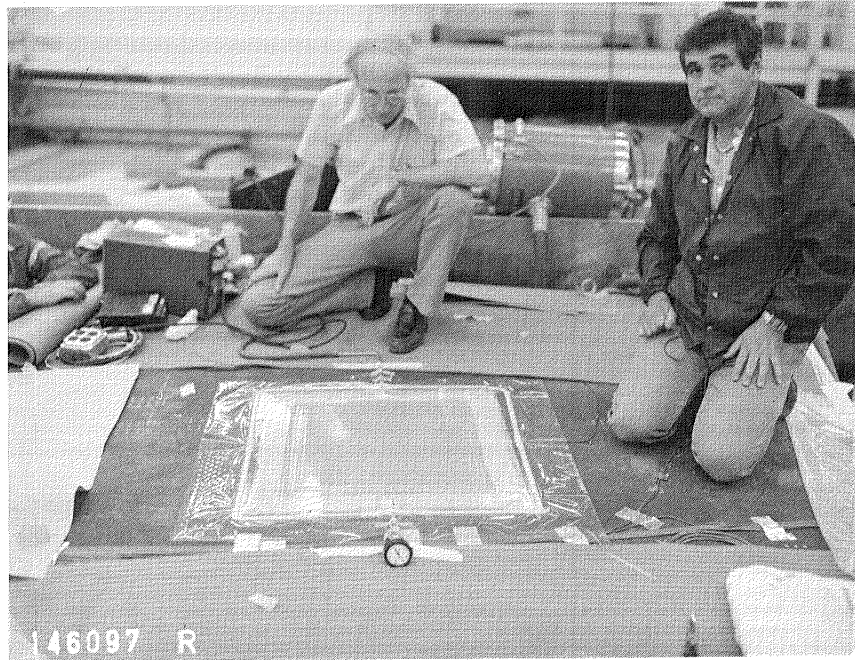
Figure 63. - Repair in place and bagged.

Three new stacks were prepared and bonded in place. The heat up rate was reduced to 3°F/min from the recommended 6°F/min. The edges of the repair only reached 273-276°F. When the center reached 355°F, the cure was extended to two hours based on the vendor recommendation. Full vacuum was held throughout the cure.

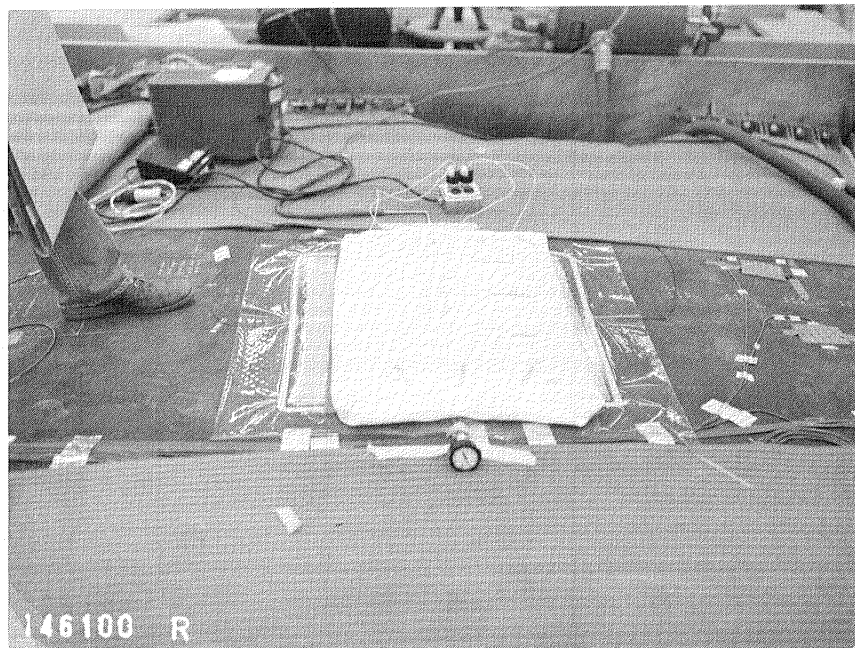
Figure 64. - Heater blanket in place.

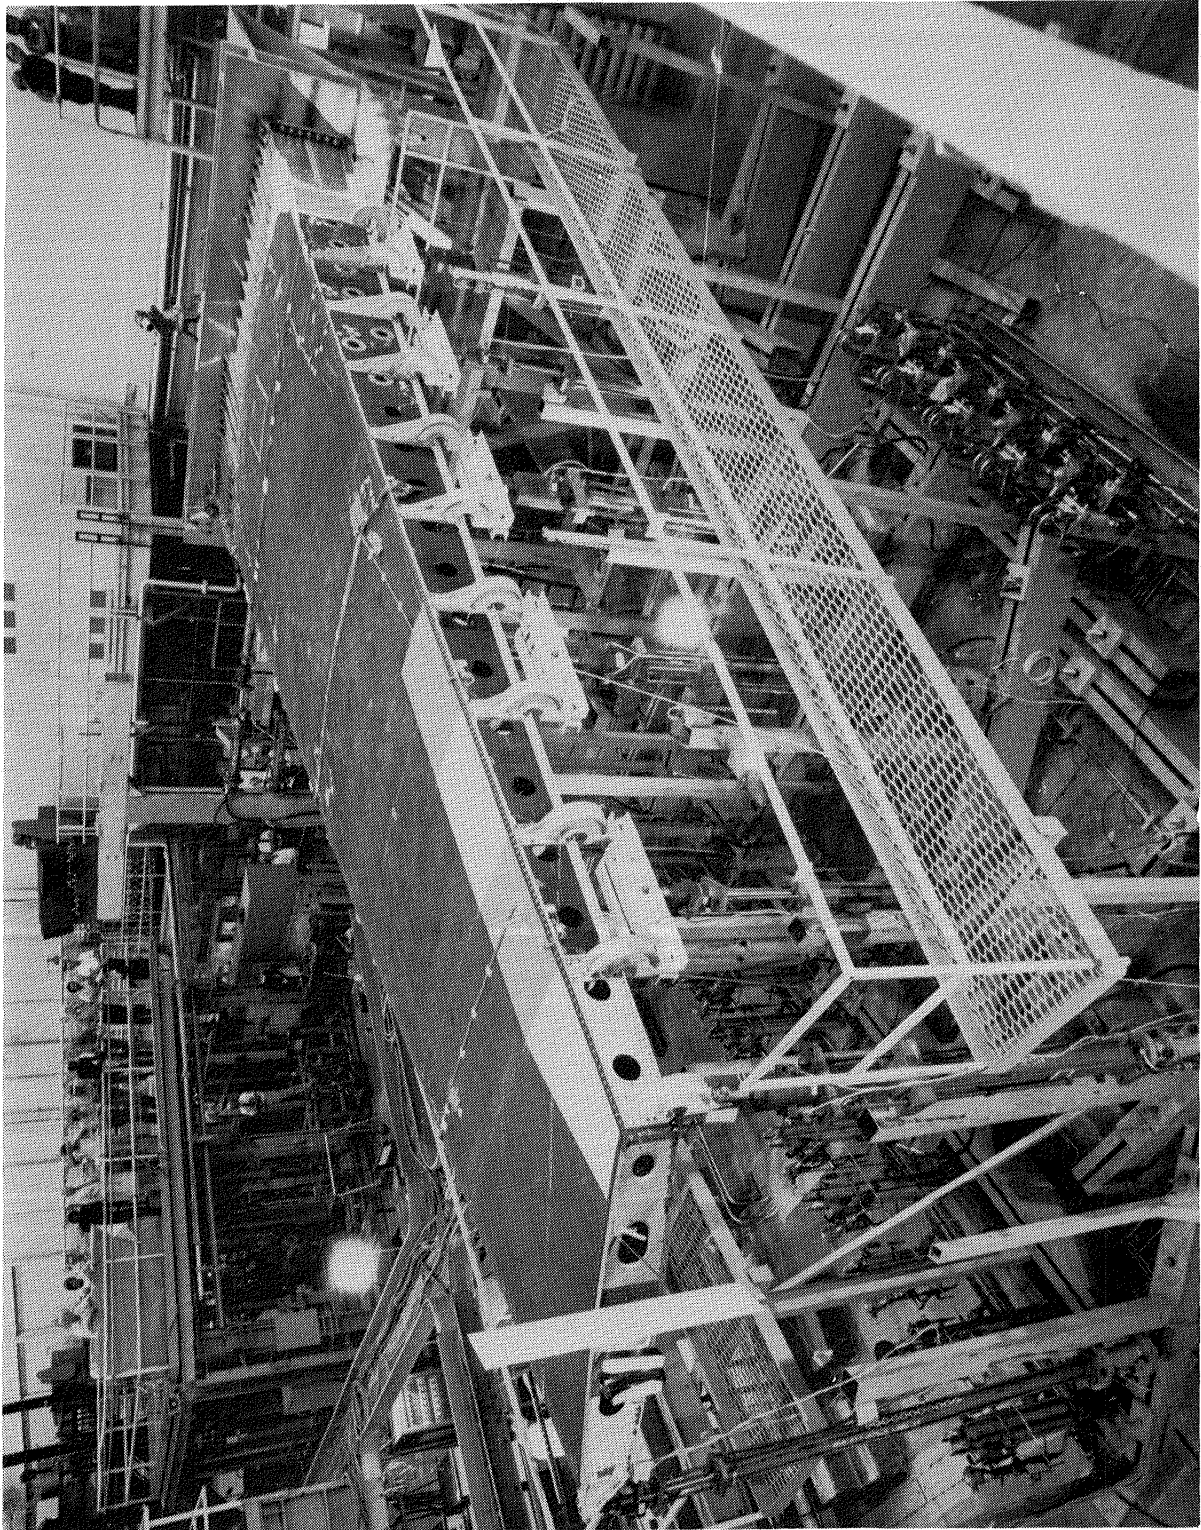
The testing of GTA No. 2 was completed on July 8, 1982 when the static test to failure was performed. Failure occurred at 119.7% DUL in the left hand (tension) cover near the front spar and between ribs VSS 248 and 222. Figure 65 shows the fin just prior to failure and Figure 66 shows the fin just as failure occurred.

Figure 65. - Fin box just prior to failure.

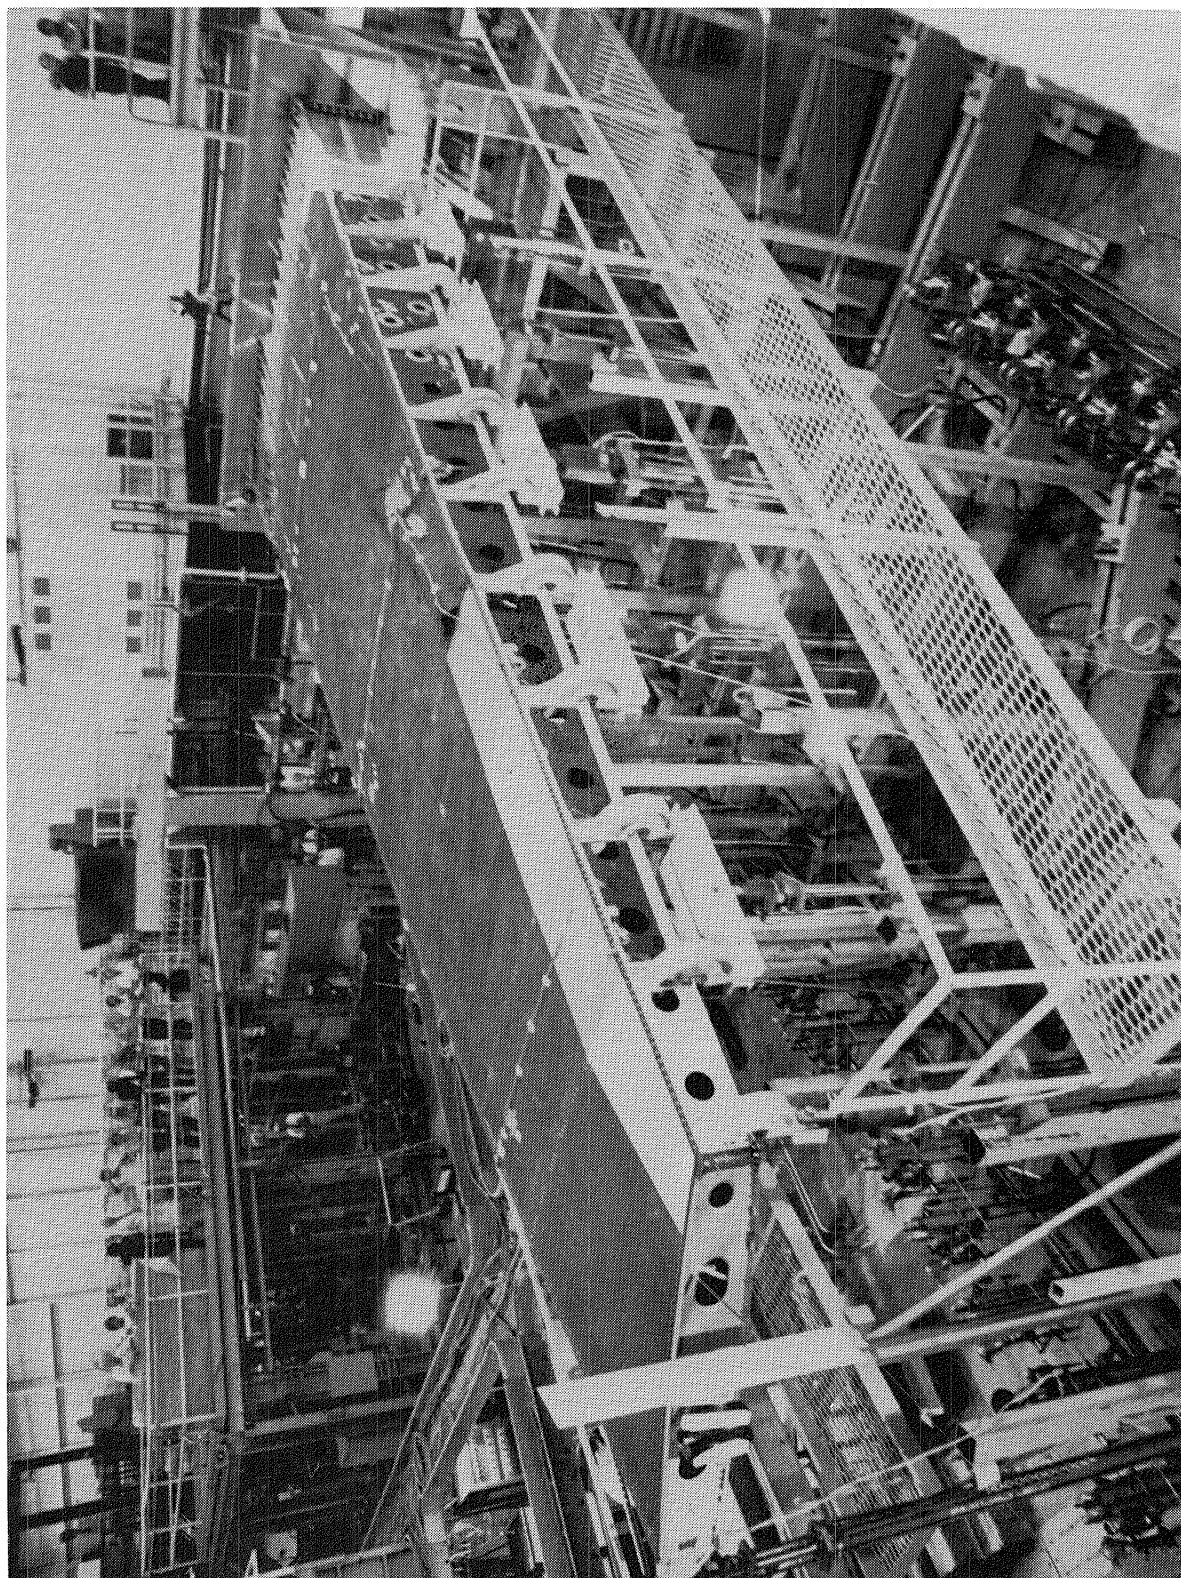
A review of the high speed movies of the test showed that the failure initiated at the lower end of the bay adjacent to the VSS 222 rib and then propagated up to VSS 248.

The initial failure was caused by high interlaminar tension stresses induced by shear buckling of the skin panel between VSS 248 and VSS 222 and between the front spar and stiffener No. 10. Buckling initiated about design

Figure 66. - Fin box at moment of failure.
